Manhole Inspection Summary

Manhole # S35WW1012MH

Insp Date: **1/30/07 1:09 PM**

Location Address: **329 TUNBRIDGE RD**

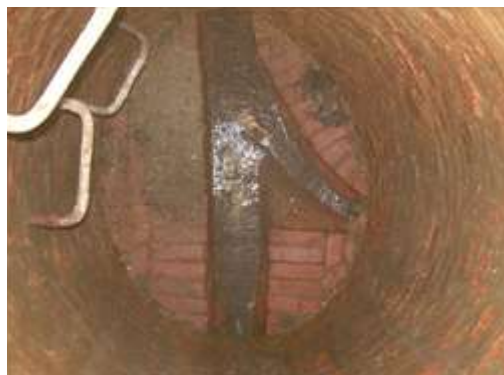
Top View

Corroded steps. Evidence of surcharge - Bench debris. Channel debris.

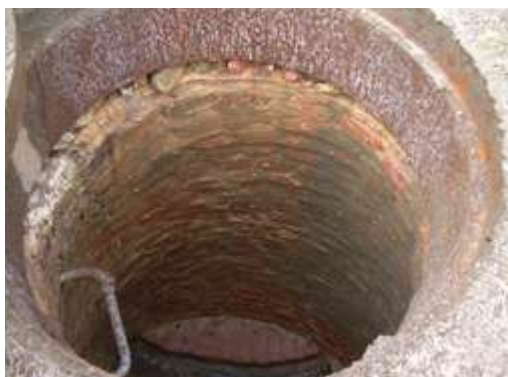
Defect

Frame leaks. Cracked frame. Adjustment deterioration, loose brick and infiltration. Barrel infiltration.

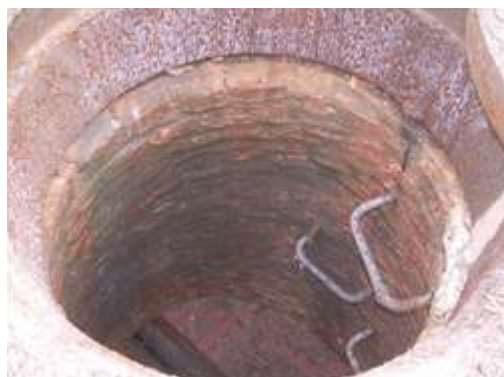
Defect

Adjustment and Barrel infiltration - other side.

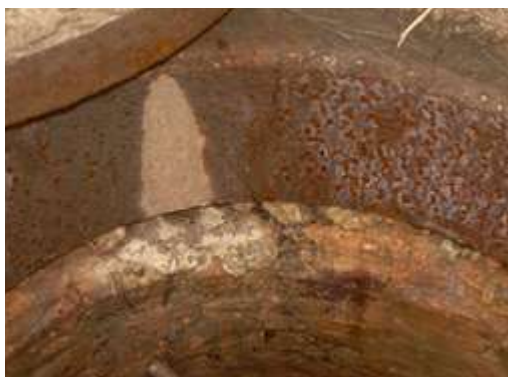
Defect

Frame leaks. Frame offset. Cracked frame. Adjustment deterioration and infiltration.

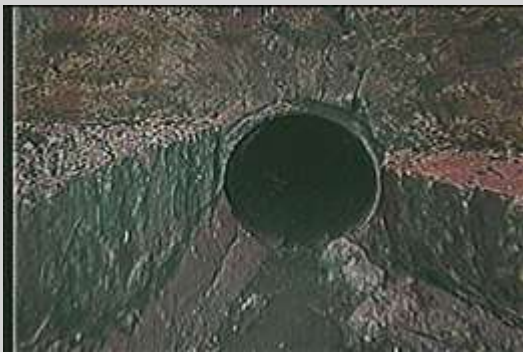
8 in. Circular Gravity Sewer Pipe Out @ 12 O'Clock

Deposits: ☐ None ☒ **Mud** ☐ Sludge ☒ **Debris** ☐ Grease

Infiltration: **Evidence** Pipe Seal Cond: **Unknown**

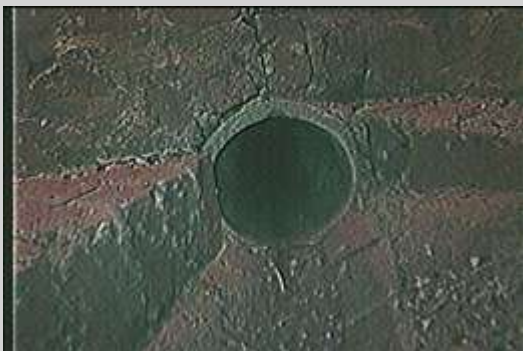
6 in. Circular Gravity Sewer Pipe In @ 4 O'Clock

Barrel deterioration and infiltration.

Infiltration: **Evidence** Pipe Seal Cond: **Cracked**

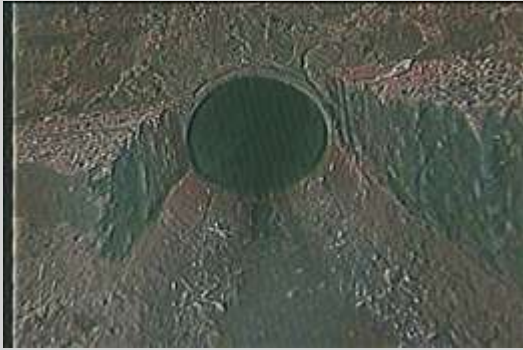
Pipe In @ 7 O'Clock

Channel deterioration.

Pipe Seal Cond: **Cracked**
